Huddleston-Berry
Engineering & Testing, LLC

September 29, 2015
Project#01302-0002

Subject: Engineering Evaluation
Upper Gladstone Ponds
Gold King Mine

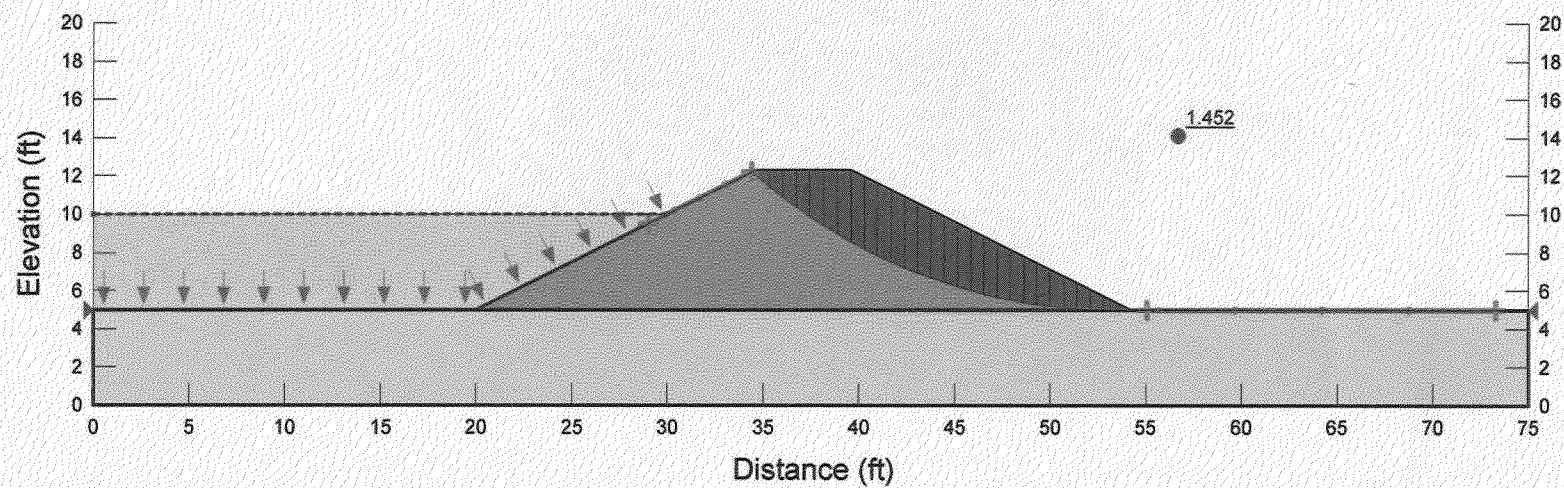
Upper Gladstone Ponds Critical Section

Analysis of the embankment was completed using the SLOPE/W computer software program. The Morgenstern-Price methodology was utilized in the analysis.

The results of the analysis yielded a Factor-of-Safety (FS) of 1.452. This is less than the FS of 1.5 typically required for long-term stability.

Information regarding the berm construction was provided to HBET by Weston Solutions, Inc. (Weston). A drawing titled *Upper Gladstone Ponds* prepared by Weston and dated September 25, 2015 suggests that the maximum berm height is approximately 7.3 feet based upon the spot elevations on the drawing. The following additional information was provided by Weston:

- The berm was constructed of non-plastic sandy gravel soils
- The berm was constructed using approximately 1 foot lifts
- The berm was compacted with the excavator bucket
- The berm material was dry
- The maximum height of water in the ponds is 5 feet
- The berm side slopes are approximately 2H:1V
- The top of the berm is approximately 5 feet wide
- The subgrade below the berm is fairly level

- $\gamma = 120$ pcf
- $\phi' = 28^\circ$

- $\gamma = 120$ pcf
- $\phi' = 26^\circ$
